MANDATORY**SERVICE BULLETIN**

DATE: October 5, 2015
 Service Bulletin No. 621B
 (Supersedes all versions of Service Bulletin No. 621A)
 Engineering Aspects are
 FAA Approved

SUBJECT: Diaphragm-Type Fuel Pump Replacement

MODELS AFFECTED: IO-320, -360, -390, -540, -580; AEIO-320, -360, -390, -540; LIO-320-B1A; O-320-B2D, -D1D; (L)O-360-A1H6, -A1N6, -A1G6D; HIO-360; LIO-360; O-360-A1H, -A2G, -A4G, -A4J, -A4K, -A1G6, -C1F, -C4F; O-540-L3C5D; and TO-360-C1A6D

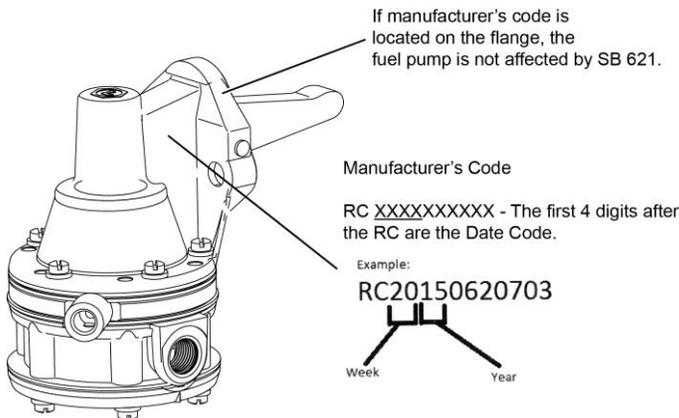
NOTICE: Each fuel pump has a 13-digit alphanumeric manufacturer's code, which begins with two letters as shown in the example in Figure 1. The alphanumeric characters in the manufacturer's code and its location on the fuel pump will help identify the fuel pumps affected by this Service Bulletin. The first two characters in the example manufacturer's code RC20150620703 in Figure 1 are **RC**. The next two numbers **20** identify the manufacturing week of the year as **20** and **15** is the year. The manufacturer's code is on the fuel pump flange or on the web as shown in Figure 1. If the manufacturer's code is on the flange as in the example in Figure 2, the fuel pump is not affected by this Service Bulletin.

Figure 1
Manufacturer's Code Location on
Fuel Pump P/Ns 62B26931 and LW-16335

1. If the fuel pump is Lycoming part number 62B26931 or LW-16335 (ordered and sold as LW-16335-S but marked on fuel pump as LW-16335).
2. If the manufacturer's code is not on the flange but is on the web or other parts of the fuel pump.
3. If the fuel pump has **RC** (Figure 1) as the first two letters of the manufacturer's code.
4. If the manufacturer's code identifies the fuel pump as manufactured before, up to, and including the 25th week of 2015.

If any fuel pump meets **all** the criteria above, remove the fuel pump from the engine or from the spares inventory and:

- A. Review your records to identify shipping dates of the serial numbers of any of the affected fuel pumps.
- B. Return all affected fuel pumps to Lycoming Engines with a copy of this Service Bulletin and file a warranty claim per the warranty procedure herein.
- C. Record removal of the fuel pump installed on the engine in the engine logbook.

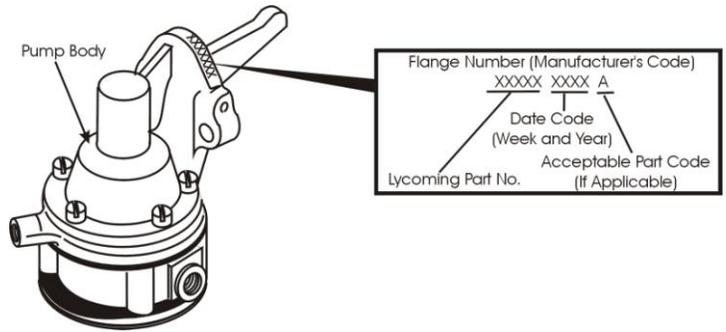
Figure 2
Manufacturer's Code on the Flange
(Fuel Pump Is NOT affected by SB-621)
